Installation of your new device should be performed by a 12V certified technician or mechanic familiar with automotive 12V systems.

Mounting Guidelines

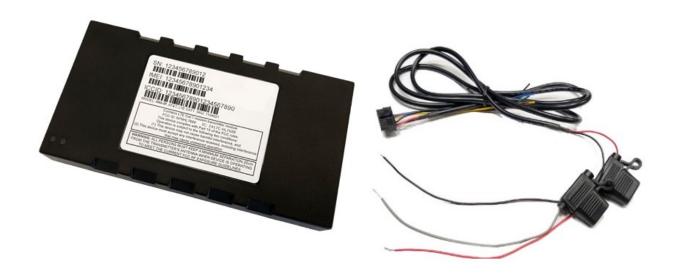
- The device should be installed under the dashboard with a clear line of sight to the sky, and as close to the windshield as possible. Place device with barcode decal "THIS SIDE TOWARDS SKY" facing up. (Reference diagram A)
- DO NOT install the unit underneath metal as the signal will not penetrate and reach the satellite.
- During initial installation, the vehicle should ideally be outside to ensure the best GPS signal. The devices may not report a location to the satellite if it is inside a garage or other structure.
- Secure the device with Velcro, and/or zip ties to ensure it is solidly mounted to the vehicle.
