IntelliShift VG-6 Installation Guide with Temperature

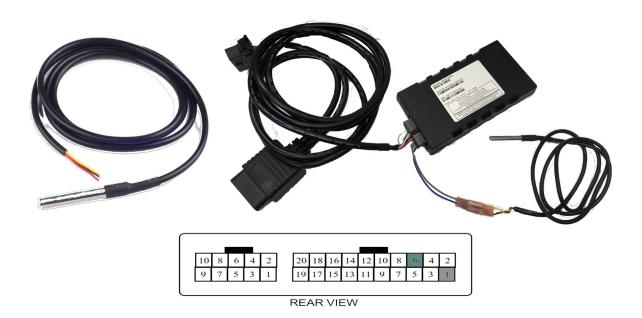
Mounting Guidelines

- The device should be installed under the dashboard with a clear line of sight to the sky, and as close to the windshield as possible. Place the device with barcode decal "THIS SIDE TOWARDS SKY" facing up. (Reference diagram A)
- DO NOT install the unit underneath metal as the signal will not penetrate and reach the satellite.
- During the initial installation, the vehicle should ideally be outside to ensure the best GPS signal. The devices may not report a location to the satellite if it is inside a garage or other structure.
- Secure the device with Velcro, and/or zip ties to ensure it is solidly mounted to the vehicle.
